**Flood Control Project Maintenance  
Levee Inspections**  
**LMA District Cover Sheet**  
**Spring 2018 Levee Inspection Results**

**Reclamation District No. 2085 Kasson**

**Spring 2018 Levee Inspection Results**

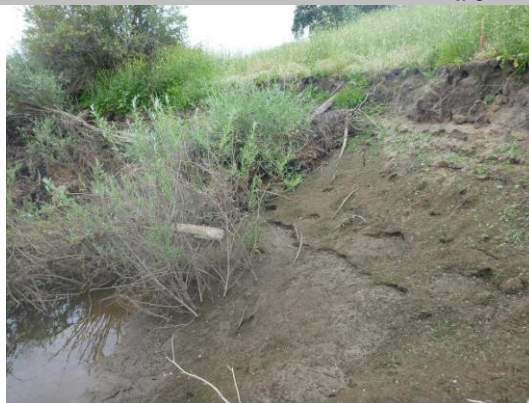
Photo 3 of 3 : LEVAL\_SP\_2018\_105\_272.jpg

LM Start	2.57	Rating **	A/W	Issue No.	48 (cont)	
LM End		Issue Type +	Ma	Location *		
Category	Supplemental			GPS Latitude/Longitude		
				Start	End	
Item	2017 Storm Damage			37.703094 °		°
				-121.274894 °		°
DWR ID	DWR_RD2085_01_f_2017_48					
Comment Code						
Inspector Comment						
Levee Evaluation Comments						
Description:						
Site ID No:105						
Site Designation:FSRP-13-55						
Repair Type: Erosion						
Rating:Serious						
Field Date:6/8/2017						
Notes:

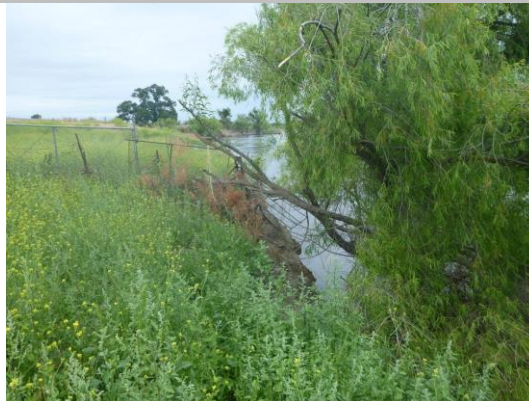
Photo 1 of 3 : LEVAL\_SP\_2018\_106\_238.jpg

LM Start	<b>3.68</b>	Rating **	A/W	Issue No.	<b>51 (cont)</b>
LM End	<b>3.82</b>	Issue Type +	Ma	Location *

LM Start	3.68	Rating **	A/W	Issue No.	51 (cont)	
LM End	3.82	Issue Type +	Ma	Location *		
Category	Supplemental			GPS Latitude/Longitude		
				Start		End
Item	2017 Storm Damage			37.688570 °		37.686620 °
				-121.276450 °		-121.276790 °
DWR ID	DWR_RD2085_01_f_2017_51					
Comment Code						
Inspector Comment						
Levee Evaluation Comments						
Description:						
Site ID No:106						
Site Designation:DWR_RD2085_01_R_2012_01						
Repair Type: Erosion						
Rating:Critical						
Field Date:6/8/2017						
Notes: Adjusted starting and ending points for this site. Site has been repaired.
